# River Yealm Water Quality

## Westcountry Rivers Trust Citizen Science Investigation

### Report 2\*

### Findings from July 2022 - April 2025

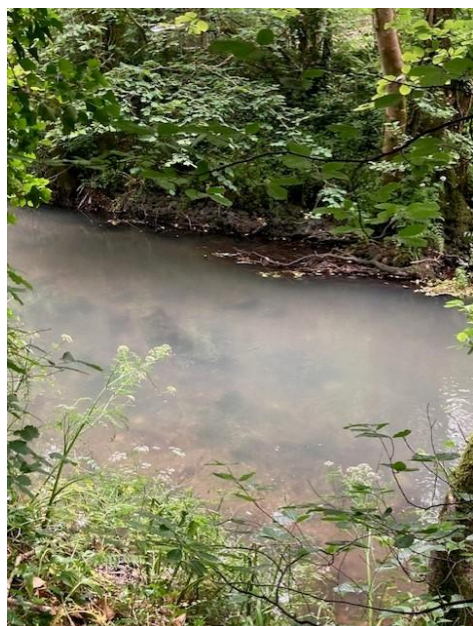
Fig 11. River Yealm July 24

**July 2025, River Yealm** - cloudy from below Luton STW down to Puslinch. Incident was reported 3 times to the EA by Yealm Responders. Luton STW is known to have been under repair.

**July 2024, River Piall and Yealm** - Rebecca Smith MP was engaged to follow up the incidents with the EA. Response indicated that the discolouration was due to the compliant discharges from 2 quarry sites upstream of Luton.

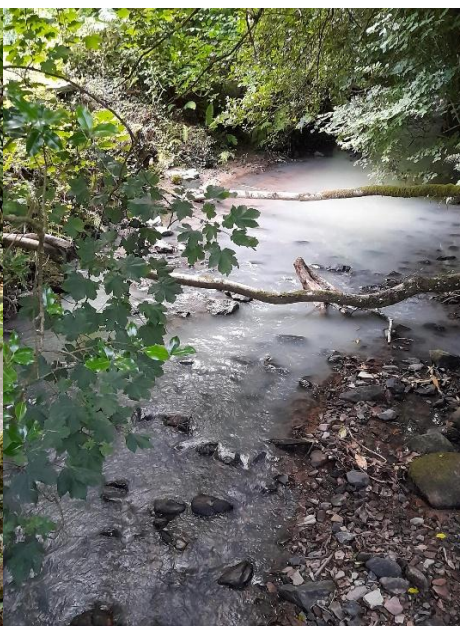
Fig 12. River Piall July 25

**May 25, River Piall** - saw a significant input of China clay-like material in the absence of previous rainfall.
